# NEW APPLIED TECHNOLOGY, EFFICIENCY AND LIGHTING INITIATIVE

## FINAL ENERGY AUDIT REPORT

# Final Energy Audit Report

For the common area of the high-rise

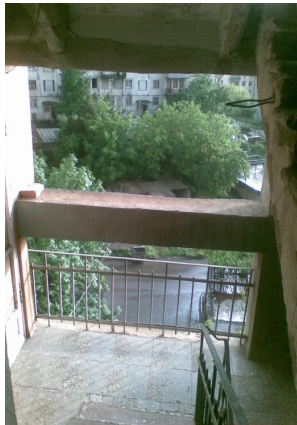
**Fig. 2.1.1** Stair-well in Mukhiani

By design or due to broken windows most of the stairwells are not isolated from outside temperatures and air circulation. As a result the internal stairwell walls have practically become external walls for the apartments and cause additional excessive heat losses.

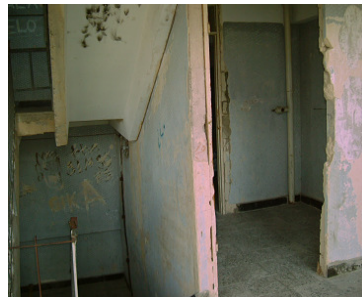
In most cases the doors of apartment access corridors that were envisaged by initial design are also missing (fig. 2.1.4).

**Fig. 2.1.4** stairwell and entrance to corridor in Petrisi str.

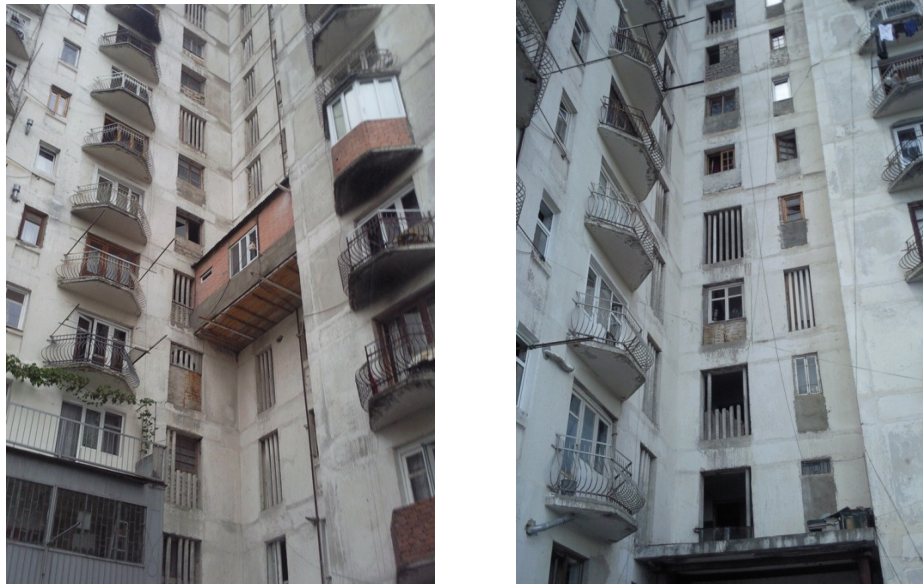
A common practice is “privatizing” part of the common area and transforming them into private premises of the residents. In some cases this has helped to reduce the heat losses from common

areas but in general it has a significant negative impact on the exterior facade of the building (fig. 2.1.5)

**Fig.2.1.5** General view of the building in Vazisubani district

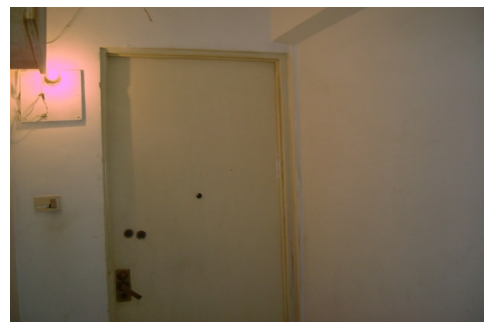
In some cases electricity was cut due to unpaid bills and residents arranged individual lighting. Being probably the only reasonable decision in this situation this measure, however, is very energy inefficient. As a result entrances are unlit in most cases, the stair-wells are either unlit or lit from several apartments simultaneously. This is neither efficient nor safe.

**Fig. 2.2.2** Individual lighting in Didi Digomi

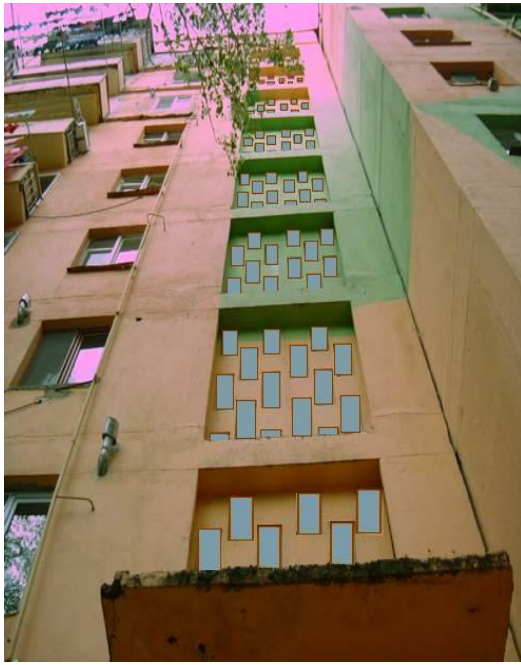
Fig. 3.1. Gldani. Carbolux windows are arranged in decorative stair.

There are a number of buildings with the entrances having decorative perforated walls or openings fitted with a number of decorative pipe-like columns. In this case it was recommended to use Carbolux type plates to close the openings.

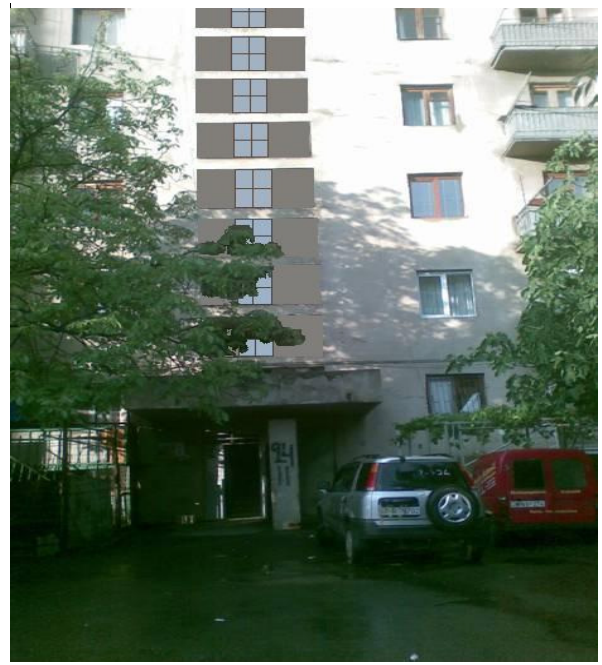
Fig.3.2. Mukhiani. Masonry and new arranged windows
