NEW APPLI TECHNOLOGY, EFFICIENCY AND LIGHTING INITIATIVE

COOPERATIVE AGREEMENT NO. 114-A-00-05-00106-00

Design of building envelope insulation, with external appearance of the buildings

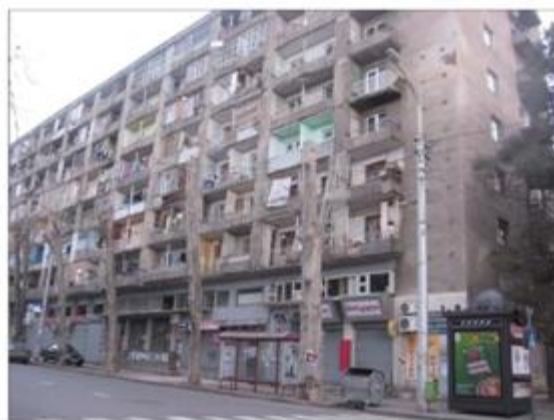
Vaja Pshavela Avenue, IV district, I building

The attached photos clearly indicate that the building is not of a high artistic-architectural value, right from the beginning. Later in time its appearance has deteriorated further and now it has an unpleasant exterior that can be often seen in Vake-Saburtalo district.

are also covered with various materials of different sizes. The main decorative element of the façade, the vertical concrete gratings are also modified and deteriorated with time.

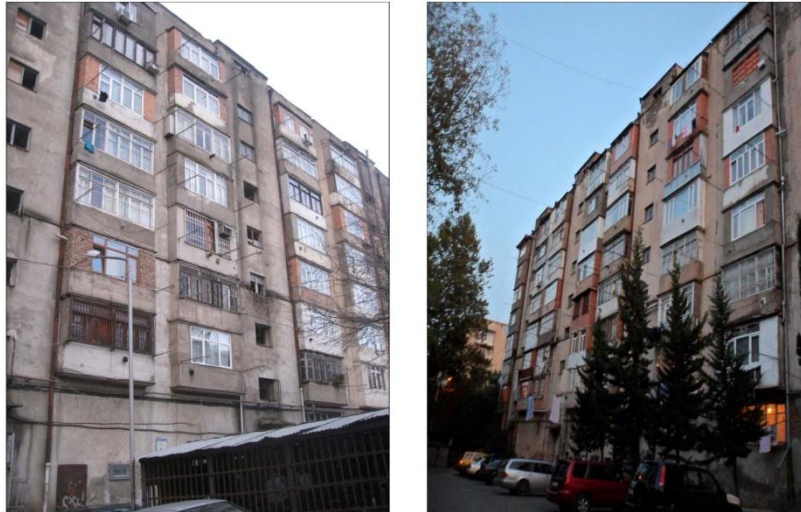
Fig.3. Northern façade of the building

The back façade (from the yard side) is in the same poor condition as the front one. There are verandas modified with masonry walls and with window frames of varying sizes, forms, material locations and color. This is due to varying preferences and financial resources of different residents.

Existing situation is quite distressing since ugly modified balconies and verandas create unpleasant and unattractive environment which in turn affects residents in a negative way. Therefore it was decided to develop a façade rehabilitation project that in its sense might be developed and replicated in other similar locations. Several main goals were set by the working group including improvement of exterior visual-esthetic appearance and also, to incorporate improved comfort requirements due to thermal insulation of the block buildings.

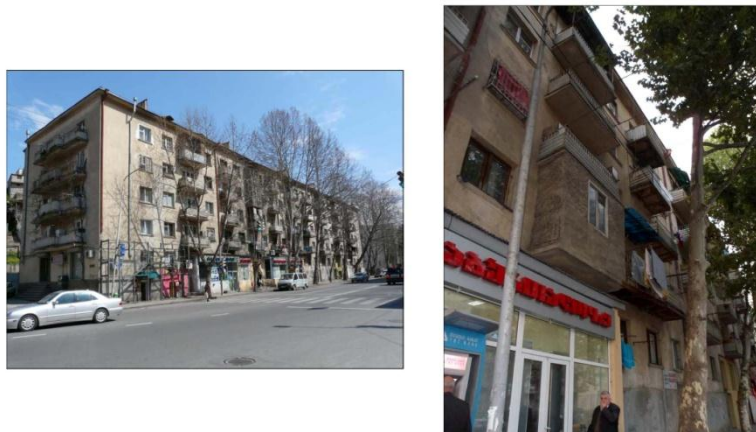
Fig 2. Southern facade

The façade of the building from south - Saburtalo Street features remodeled balconies with built masonry walls and windows that create uneven rhythm and asymmetric composition of the façade. The general appearance of the facade is violated by brick and block masonry walls that are not plastered and finished according to façade requirements in material or color. They have the rough natural appearance of material and further aggravating the face of the building. The metal railings of balconies are covered with different material in different style.

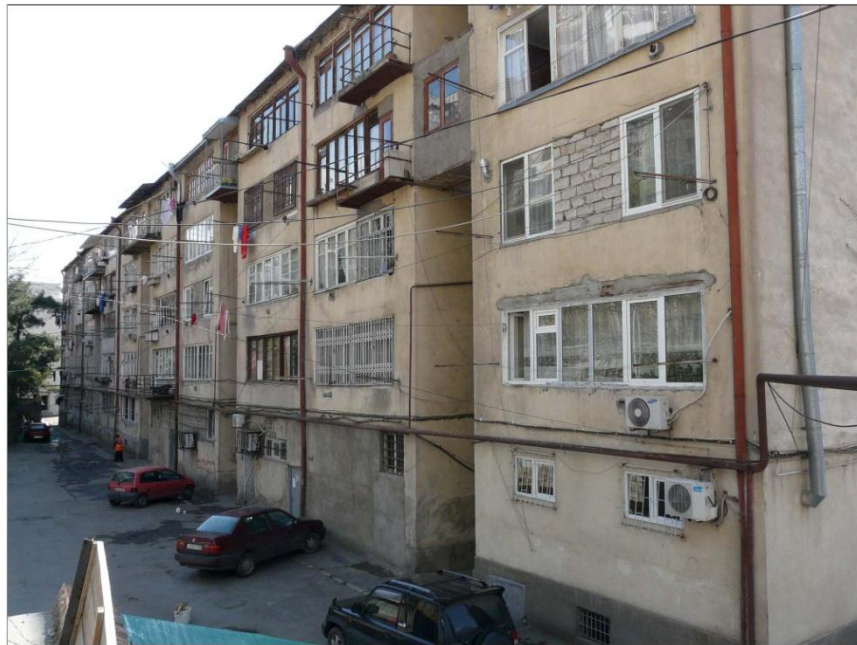
Fig 3. North back facade

The back façade (from the yard side) is in a worse condition than the front one. There are built in structures and compartments with window frames of varying sizes, forms, material locations and color. This is due to varying tastes, preferences and financial resources of different residents.

There are remodeled balconies and storage boxes and non-typical compartments built on the internal side of the house.

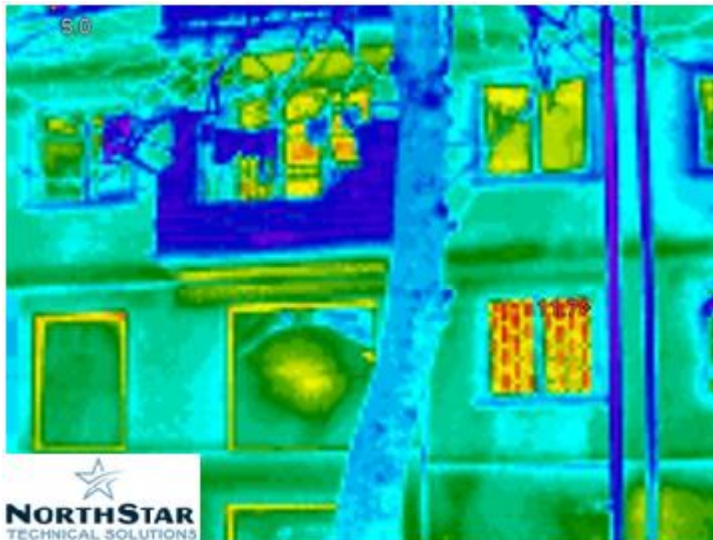
Heat energy leakage as shown through single-pane glass.

Energy leakage also depicted in typical wooden-framed glass windows.

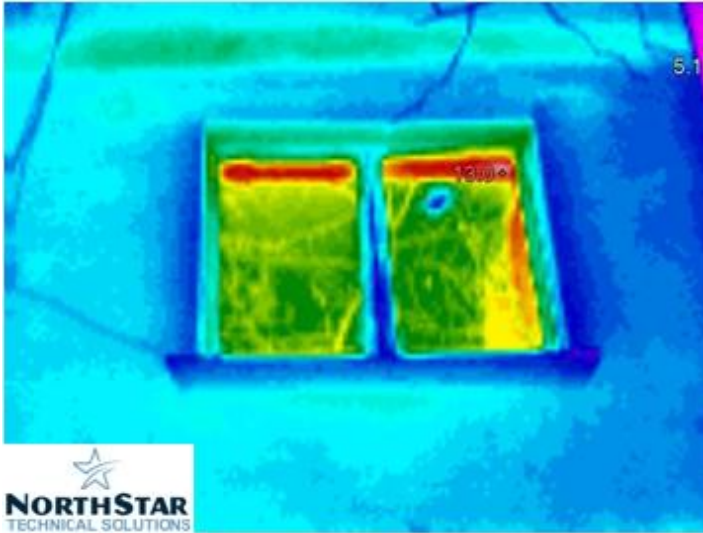
Fig. 2 Window on South façade 53/53a Saburtalo Str.

Name	Temperature
Hot Cursor	11.7°C
Cold Cursor	5.0°C

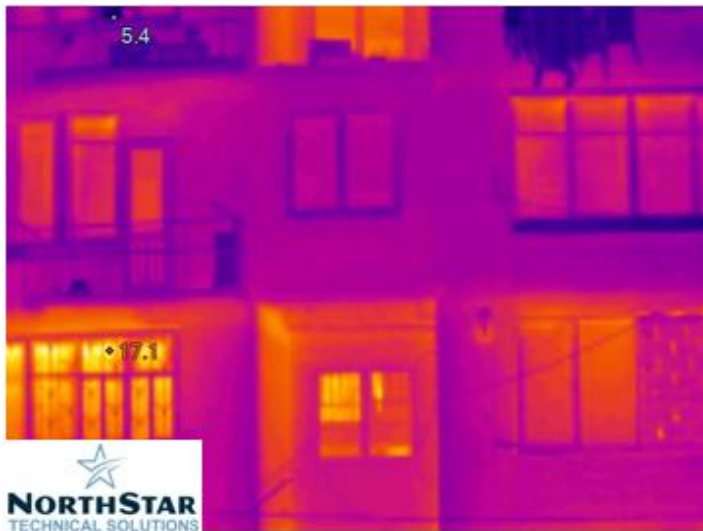
Fig.3. North façade of 53/53a Saburtalo Str.

Name	Temperature
Hot Cursor	13.0°C
Cold Cursor	5.1°C

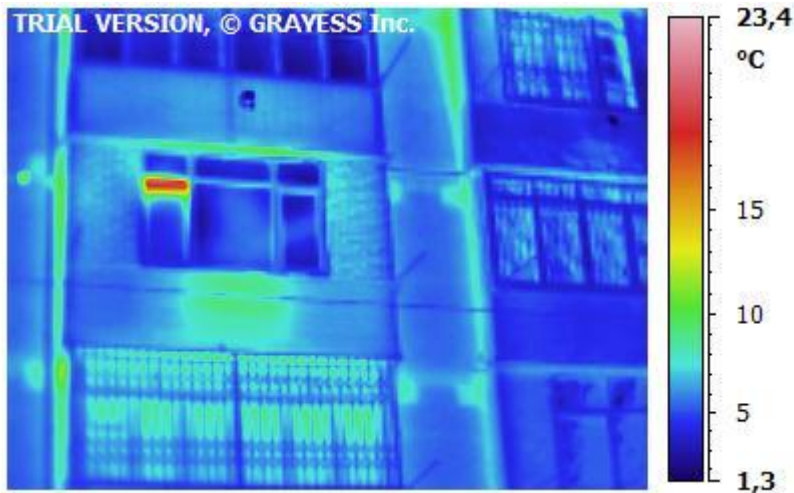
Fig.4. North façade Vazha-Pshavela Ave.

Name	Temperature
Center Point	10.1°C
Hot Cursor	17.4°C
Cold Cursor	6.8°C

Location of heater and energy leakage from open vent can be easily identified. One can also notice that the side-walls of the verandas are the source of the highest thermal losses from the walls.
