NEW APPLI TECHNOLOGY, EFFICIENCY AND LIGHTING INITIATIVE

COOPERATIVE AGREEMENT NO. 114-A-00-05-00106-00

Design of building envelope insulation, with external appearance of the buildings

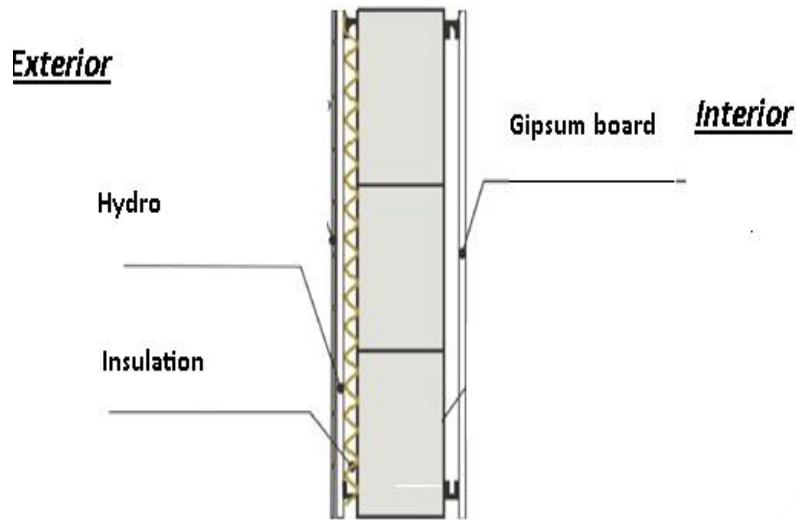
Fig 1. Suggested scheme of insulation of external walls with basalt non-woven bats.

At the same time the basalt mat as it is produced now is more appropriate for thermal insulation in high temperature industrial processes and requires development of adequate technology to be successfully applied in building insulation. The arrangements suggested by the vendor are shown below. According to BPG the most appropriate use of basalt mat is for internal insulation of the walls.

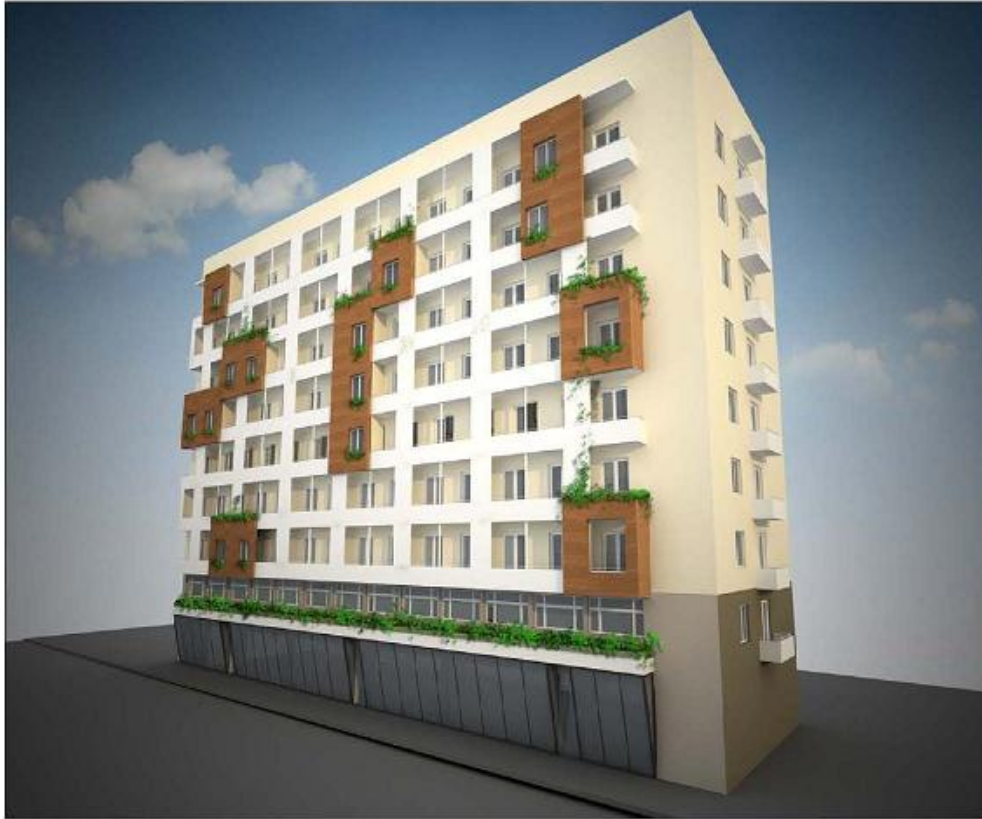
Fig.4. South façade after rehabilitation

The iron railings of the balconies and vertical gratings of the northern façade shall be filled with partition blocks or brick peaces, putted, processed with prime coating, plastered and shall be painted with high quality façade paint. Filling up these two elements shall create a new uniform surface that shall be colored in one color. As a result the façade will acquire more uniform and attractive surface. The existing modified balcony compartment walls will be covered with thermal insulation and treated with prime coating, textured plaster and shall be painted with bright façade paint. The wood imitation shall be achieved with this paint and will become the main decorative element of the façade. These elements shall be further emphasized with plants.

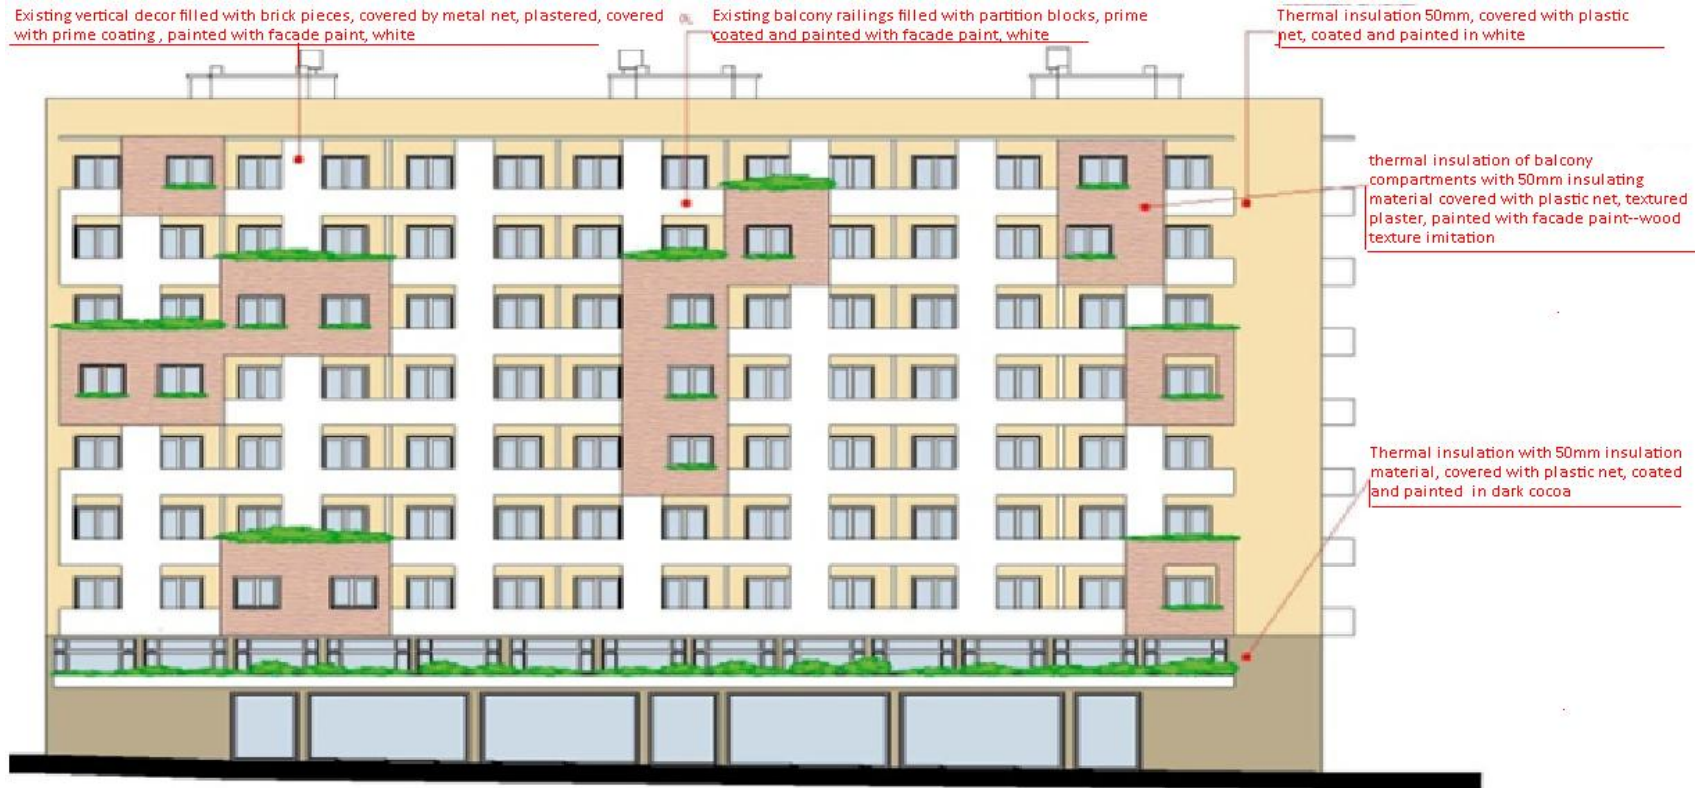
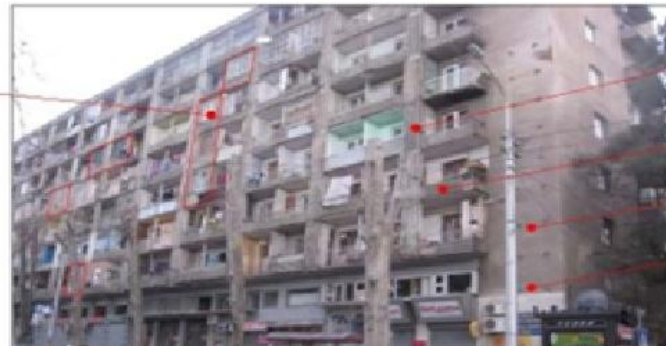
Fig.5. South façade rehabilitation details

Thermal insulation of balcony compartments with 50mm insulation material covered with plastic net, textured plaster, painted with facade paint- wood texture imitation

Existing vertical decor filled with brick pieces, covered by metal net, plastered, covered with prime coating, painted with facade paint, white

Existing balcony railings filled with partition blocks, prime coated and painted with facade paint, white

Thermal insulation with 50mm insulating material covered with plastic net, plastered, painted with facade paint- dark cocoa

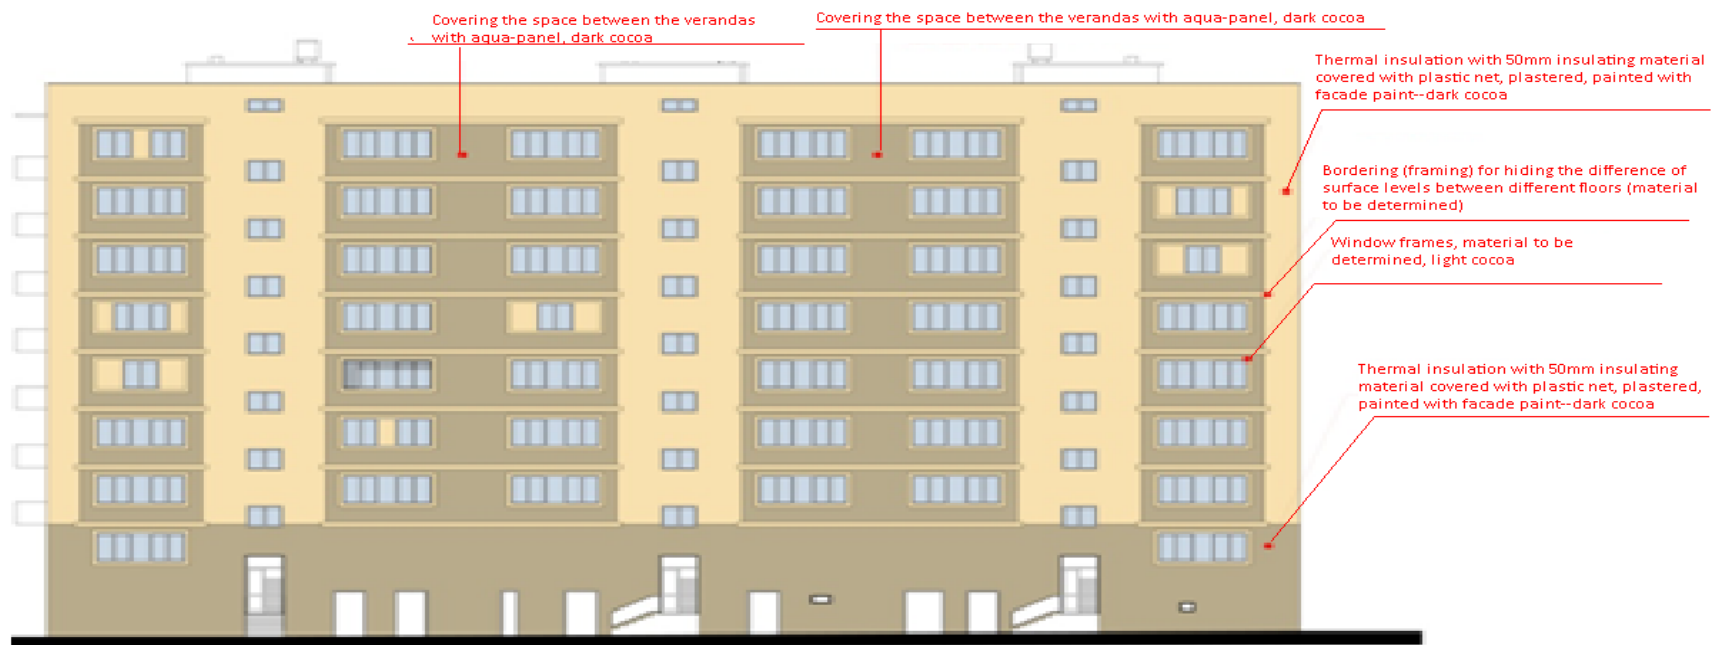
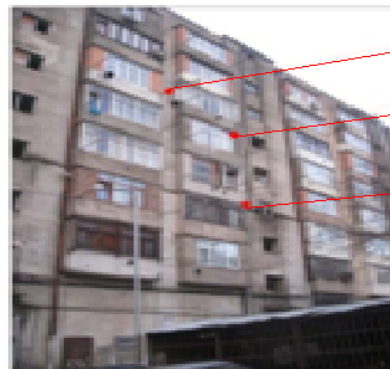
Fig.6. North façade rehabilitation details

- Covering the sapce between balconies with aqua-panel
- Window frames, material to be determined, light cocoa
- Bordering, (framing) for hiding the difference of surface levels between different floors (material to be determined)

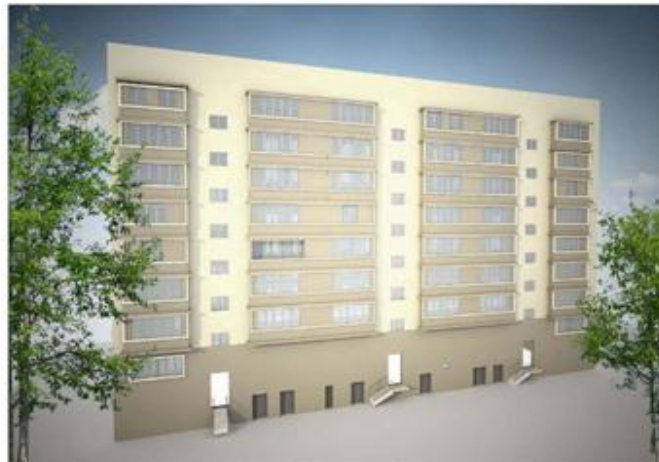
Fig.7. North façade after rehabilitation

The space between verandas shall be covered with aqua panel and the horizontal bordering panes shall be introduced to partly conceal the difference in veranda surfaces at different floors. The differences in window sizes shall be concealed by painting the veranda surfaces into darker color.

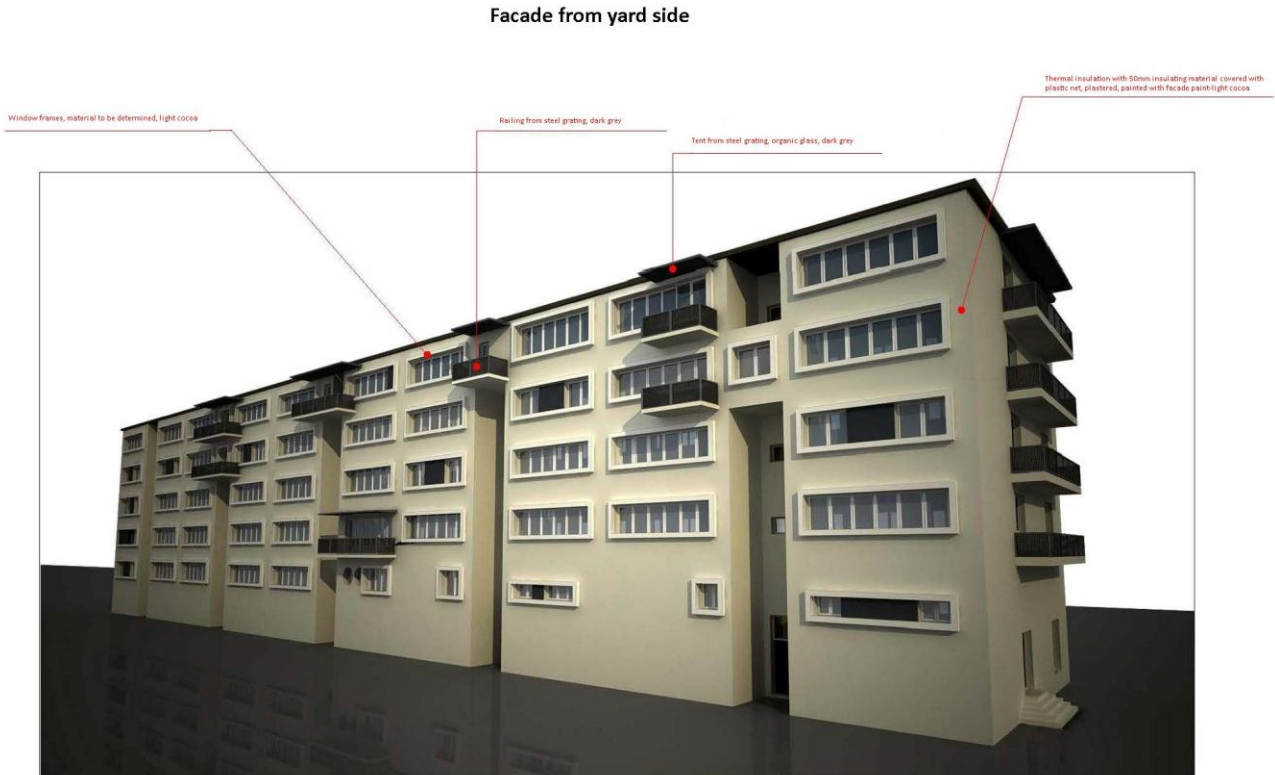
Fig 5. North façade from yard side

The three balconies built up with masonry walls were connected to other upper balconies with the side walls so that two vertical stripes were created. The windows of different sizes were grouped in a way that allowed creation of an interesting composition picture. The balconies were equipped with iron nets. The facades shall be covered with insulation material, plastic net, prime covered and painted with façade paint. A hood was created on top of commercial spaces where plants can be seeded and grown. This will add the beauty and attractiveness to the house.
